Memorandum

Subject: Honda briefing at ODI, September 4, 2003

To: Public File, PE03-039 - Honda Briefing Materials

Honda requested the September 4th meeting to discuss lower crossmember failures on certain 2002/2003 model year GL1800's. This issue was (is) the subject of the National Highway Traffic Safety Administration (NHTSA) Office of Defect Investigations (ODI) Preliminary Evaluation (PE) 03-039. We opened this investigation after becoming aware of crossmember separations and resulting rear suspension collapse involving these motorcycles.

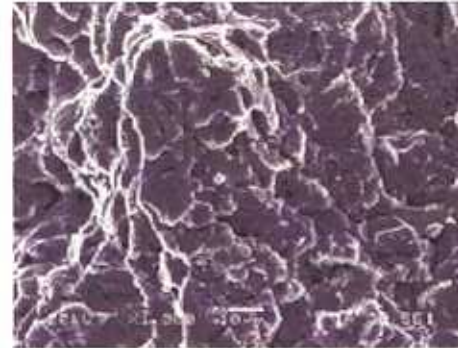
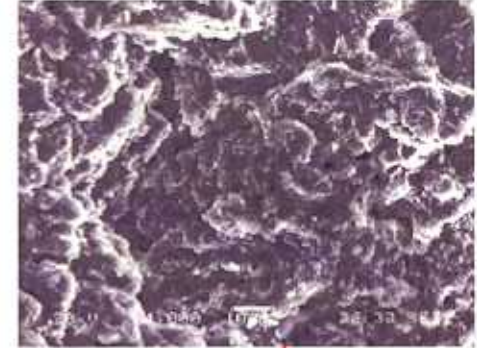
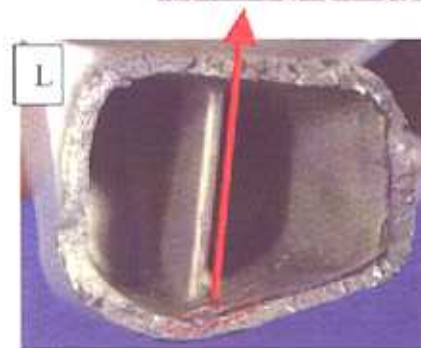
1. Confirmation of actual parts –①

Analysis of broken surface

1. Breakage originated from the inside of the welded area.
2. Breakage was caused by a one-time impact. (Not fatigue broken)

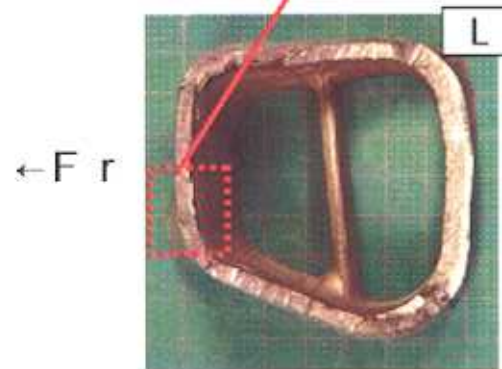
1. Confirmation of actual parts –②

Analysis of Crack surface

1. Breakage originated from the inside of the welded area.
2. Breakage was caused by a one-time impact.
(Not fatigue crack)
