U.S. Department
of Transportation
**National Highway
Traffic Safety
Administration**

ODI RESUME

Investigation: PE 03-039
Prompted By: OWNER COMPLAINTS
Date Opened: 08/11/2003
Principal Investigator: ROBERT YOUNG
Subject: MOTORCYCLE REAR SUSPENSION COLLAPSE

Subject: Myr 2001-2003 Honda GL1800 "Gold Wing" Suspension Collapse
due to cross-member separation.

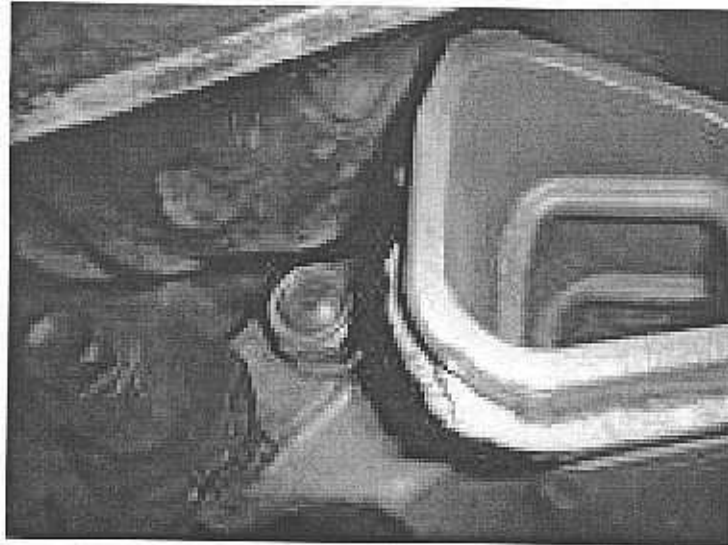
Same, close-up

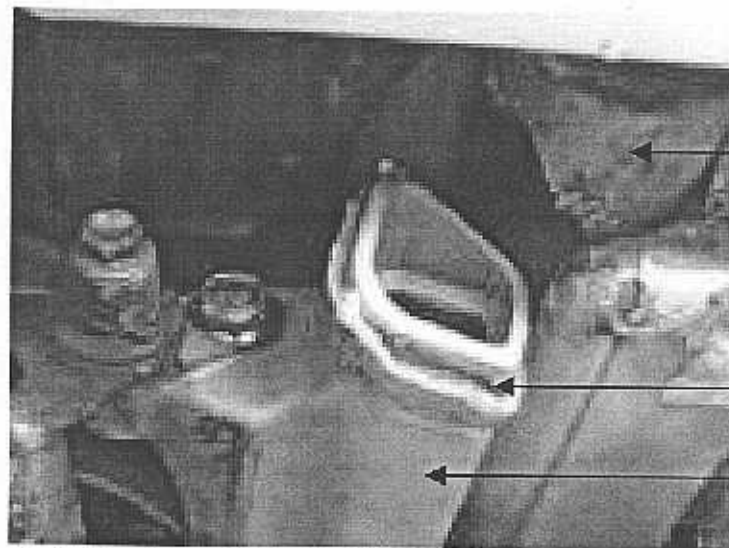
Cross-member separated while riding. VIN: 1HFSC47063A201208. Honda repurchased this motorcycle.
