U.S. Department
of Transportation

National Highway
Traffic Safety
Administration

Subject: Honda briefing at ODI, September 4, 2003

To: Public File, PE03-039 - Honda Briefing Materials

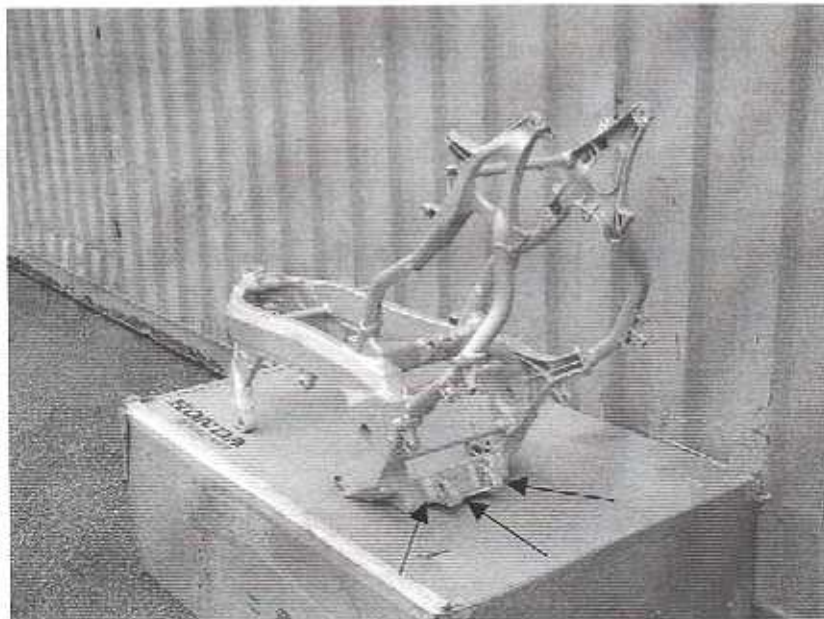
The following photograph shows the subject crossmember location.

Both the rear suspension lower linkage and the centerstand are attached to this crossmember and, should it separate from the frame, the rear suspension collapses (although the swing arm is still fully attached to the frame and its lateral positioning is fully maintained), the rear tire contacts the plastic fender liner, and the crossmember and/or centerstand drags on the ground.

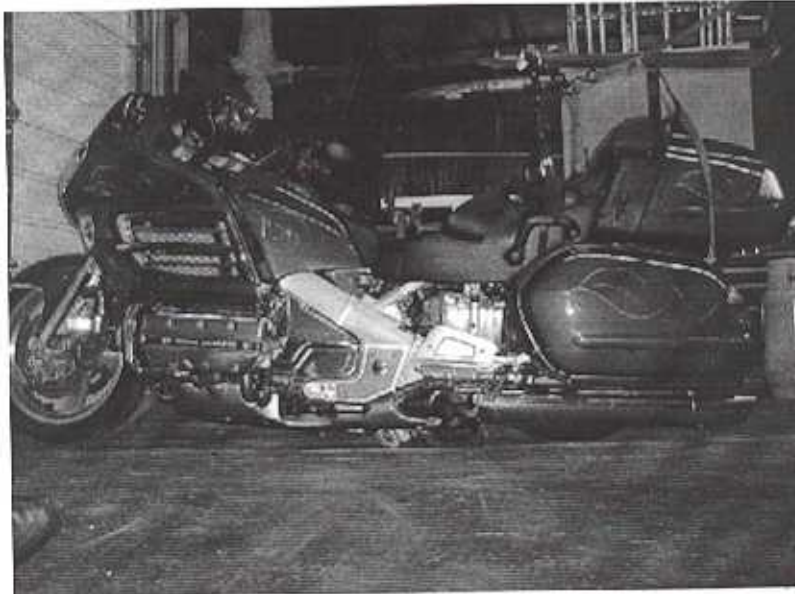
Photo 1 – 2002 GL1800 (built 6-02) w/1600 miles – Separated crossmember

While the recall notification sent to the Agency by Honda describes a remedy (i.e., the existing crossmember welds, *if not cracked*, will be reinforced with additional TIG welds applied by a person certified to perform TIG. TIG, otherwise known as Gas Tungsten Arc Welding (GTAW), is commonly used in high quality welding processes). On October 4, 2003, NHTSA received a complete "recall package" from Honda (Attachments 4 and 5) that includes a service bulletin. Page two of the bulletin tells the dealer, "If your inspection identifies a crack or cracks in or on either the Left or Right lower crossmember frame welds, **STOP** – call your DSM [District Service Manager] or TechLine for further instructions." As of October 7, 2003, Honda has not formally notified us of what action it will take to correct cracked crossmember welds that cannot, for whatever reason, be reinforced.

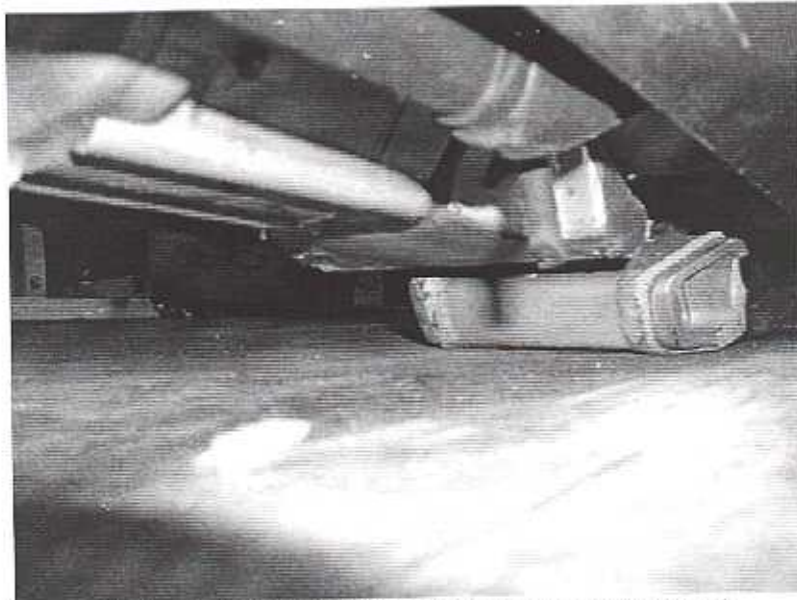
Photo 2 – Separated crossmember dragging on ground
