GL1800 Lower Cross Pipe Issue

September 04, 2003

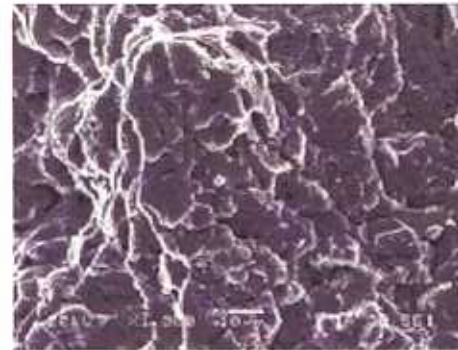
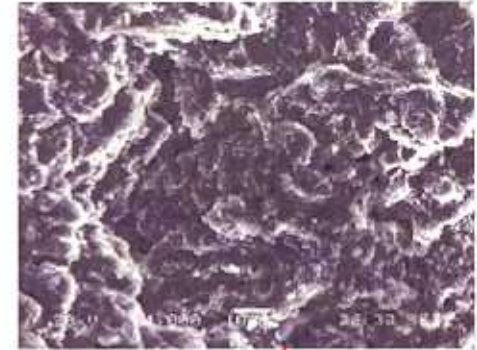
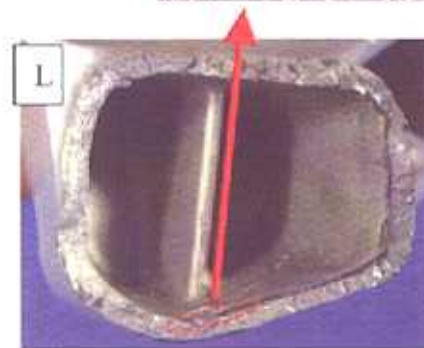
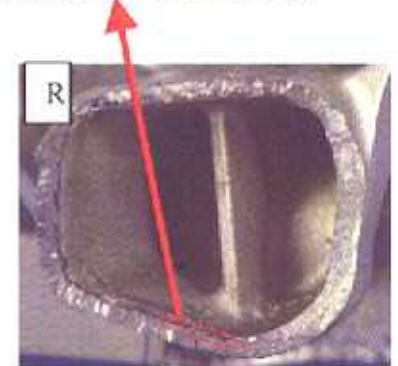
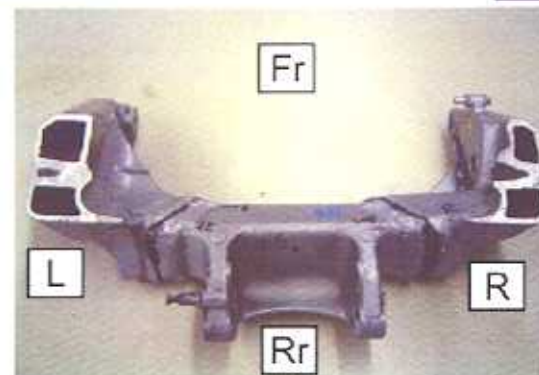
Analysis of broken surface

1. Breakage originated from the inside of the welded area.
2. Breakage was caused by a one-time impact. (Not fatigue broken)

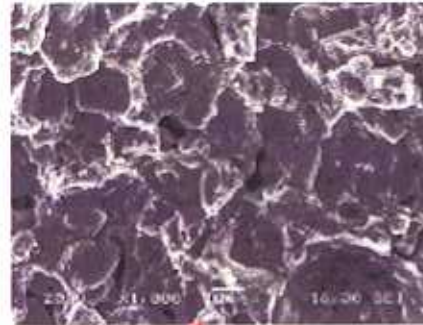
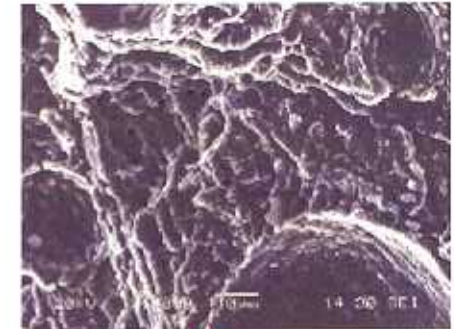
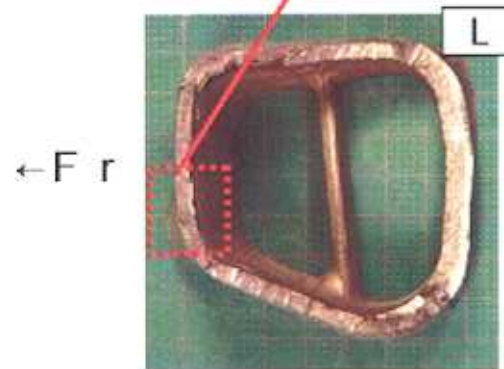
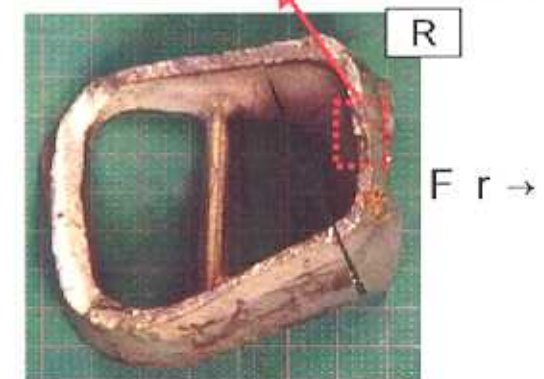
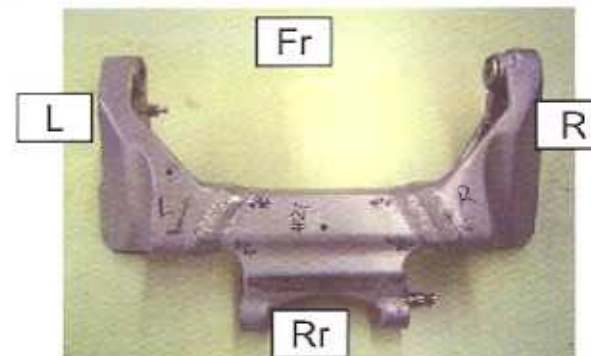
Analysis of Crack surface

1. Breakage originated from the inside of the welded area.
2. Breakage was caused by a one-time impact.
(Not fatigue crack)

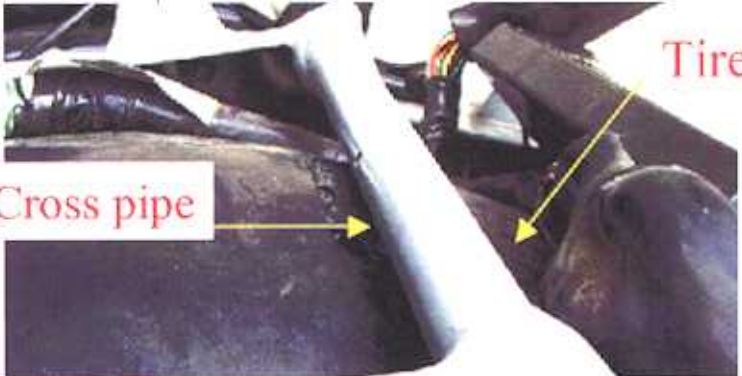
potential problem	Phenomenon	Result
①	<p>Fall</p> <p>A puncture caused by interference between the rear tire and fender.</p>

<p>The fender is made of plastic and no sharp parts are in contact with rear tire. The cross pipe is cylindrical.</p>	No puncture
	<p>The lower cross pipe contacts on the ground.</p>

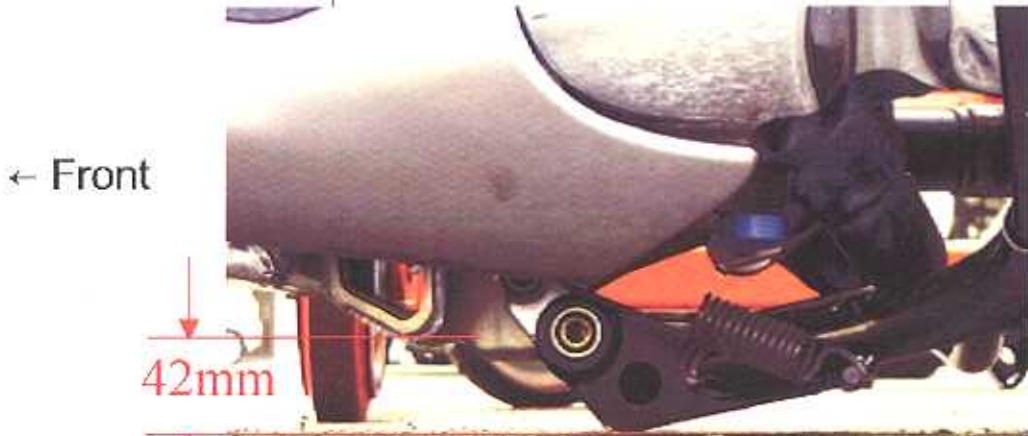
<p>The clearance between the pipe and the load surface is approximately 42mm; no contact. The bottom of the centerstand interferes with the road surface, but it does not impede running due to its curved shape.</p>	No abrupt movement

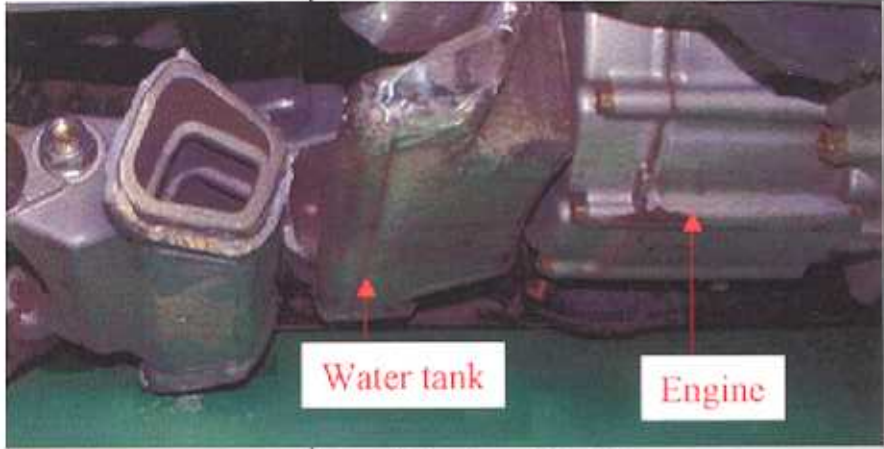
Potential problem	Phenomenon	Result
②	fall	Slip by leakage of oil or coolant

The cross pipe hangs down out of place, but it does not come off nor cause any damage to the engine case and water tank.	No damage on the engine and cooling system.
		Bank angle decrease From the video of breakage test	dynamic bank angle is 19° Normal running and turning are still possible.

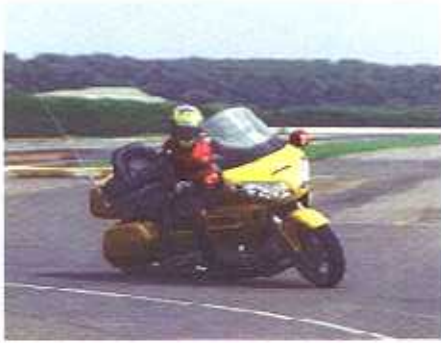
Bank angle is slightly reduced.

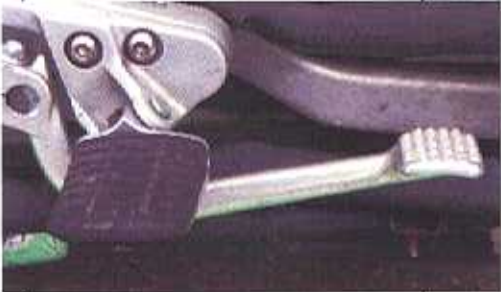
<p>No interference to related components</p> <p style="text-align: center;">Brake pipe</p>

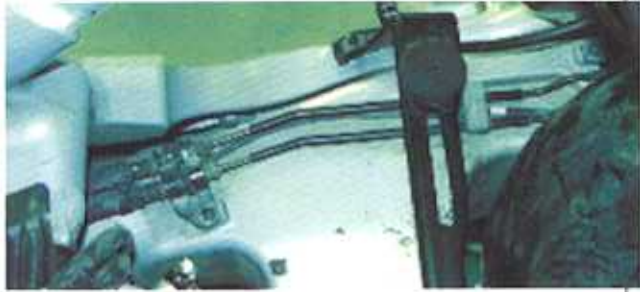
<p>No damage to any related components</p> <p style="text-align: center;">Caliper area</p>

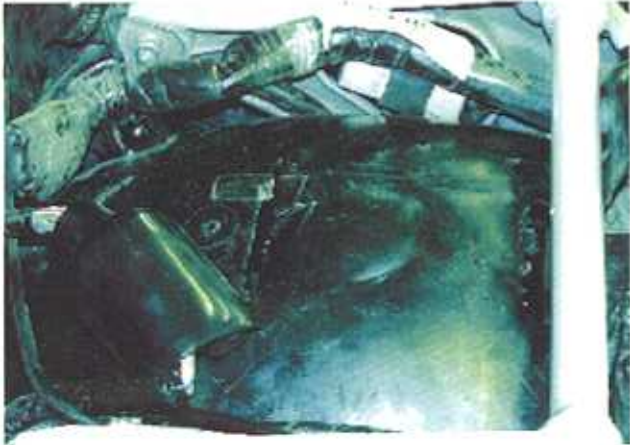
③	<p>Fire</p> <p>Electrical harness, open circuit and short circuit</p>	<p>No harness open circuit or short circuit after separation and prior to stopping</p>

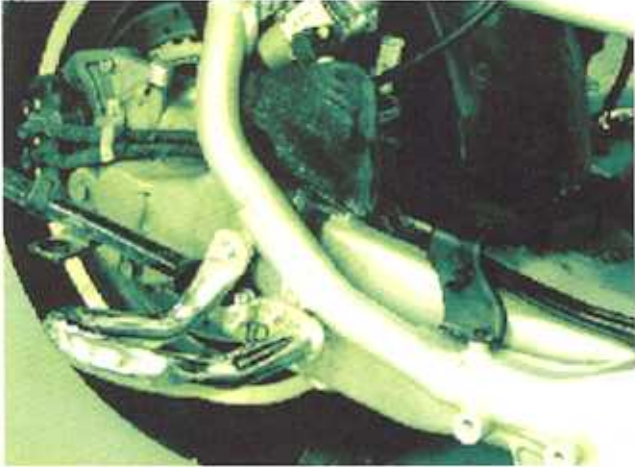
Potential problem	Phenomenon	Result
⑤	<p>Lock of the rear wheel</p> <p>In case any broken parts are caught in the rear wheel, they may cause a lock.</p>	<p>① No parts are caught in the rotating unit, no damage of the swing arm, drive shaft, and final gear.</p>

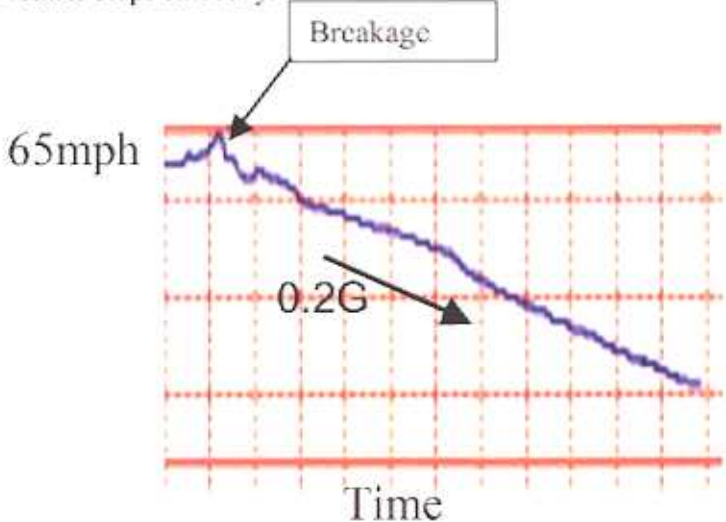
<p>No rear wheel lock occurs.</p>
	<p>Rear tire lock caused by interference from contact with fender.</p>	<p>During interference, the tire is not locked. The speed reduction is smooth, and the vehicle stops smoothly.</p>

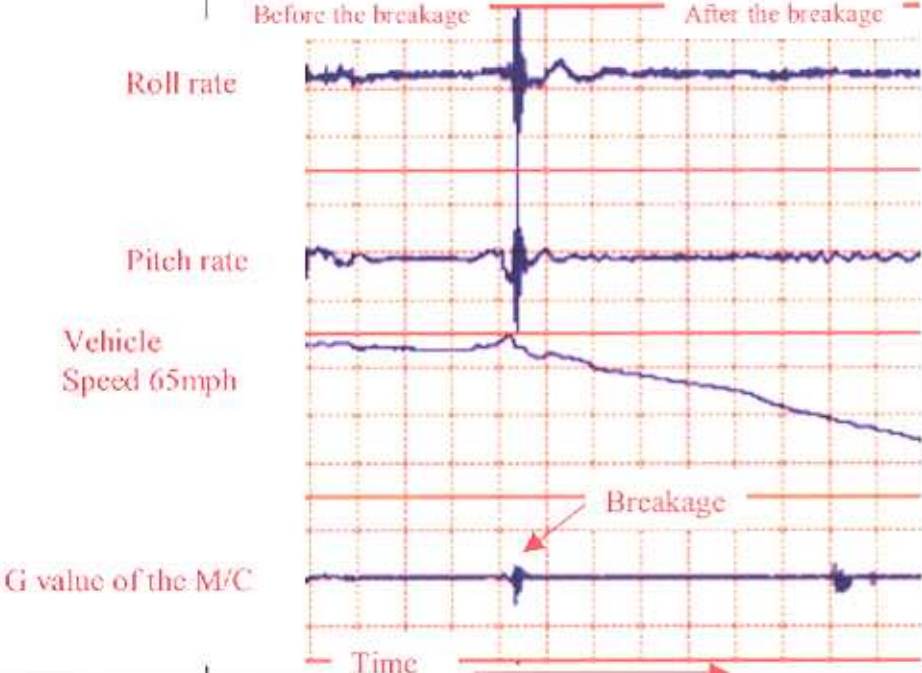
Potential problem	Phenomenon	Result
⑥ Injury of the rider	Possibility of the rider being thrown from the bike by the shock of the cross pipe failure.	<p>Very slight shock at the moment of failure. No significant difference in pitch rate and roll rate of body before and after the failure.</p>

Rider remains on motorcycle.
	Parts dislodged from motorcycle can cause injury to the rider.	No parts are dislodged	No injury to rider.
