Service Bulletin

SAFETY RECALL

2002-2003 GL1800/A Frame Weld

American Honda is conducting a Safety Recall on affected 2002-2003 GL1800/A Gold Wings to reinforce frame welds.

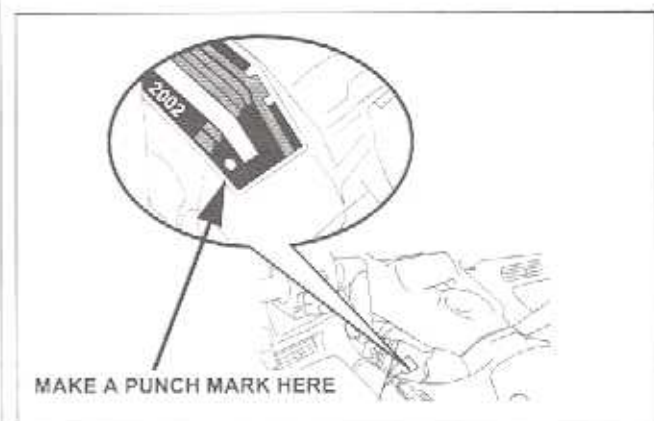
REPAIR IDENTIFICATION

After you have completed the disassembly, welding, painting, and re-assembly procedures, make a punch mark on the lower right hand corner of the VIN plate, as shown below.

If the unit has been repaired, you should find a punch mark on the lower right hand corner of the VIN plate (see IDENTIFICATION).
