Memorandum

Subject: Honda briefing at ODI, September 4, 2003

To: Public File, PE03-039 - Honda Briefing Materials

Honda requested the September 4th meeting to discuss lower crossmember failures on certain 2002/2003 model year GL1800's. This issue was (is) the subject of the National Highway Traffic Safety Administration (NHTSA) Office of Defect Investigations (ODI) Preliminary Evaluation (PE) 03-039. We opened this investigation after becoming aware of crossmember separations and resulting rear suspension collapse involving these motorcycles.

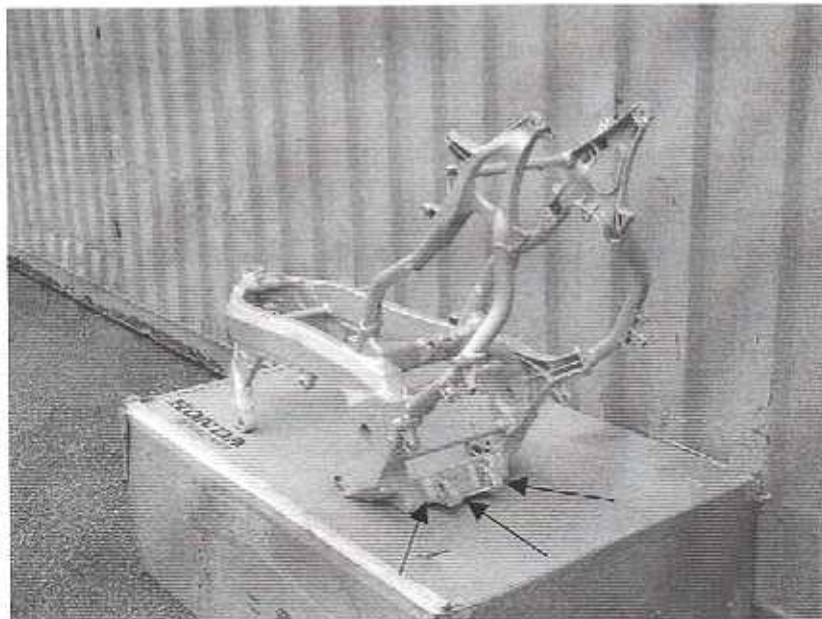
The following photograph shows the subject crossmember location.

Both the rear suspension lower linkage and the centerstand are attached to this crossmember and, should it separate from the frame, the rear suspension collapses (although the swing arm is still fully attached to the frame and its lateral positioning is fully maintained), the rear tire contacts the plastic fender liner, and the crossmember and/or centerstand drags on the ground.

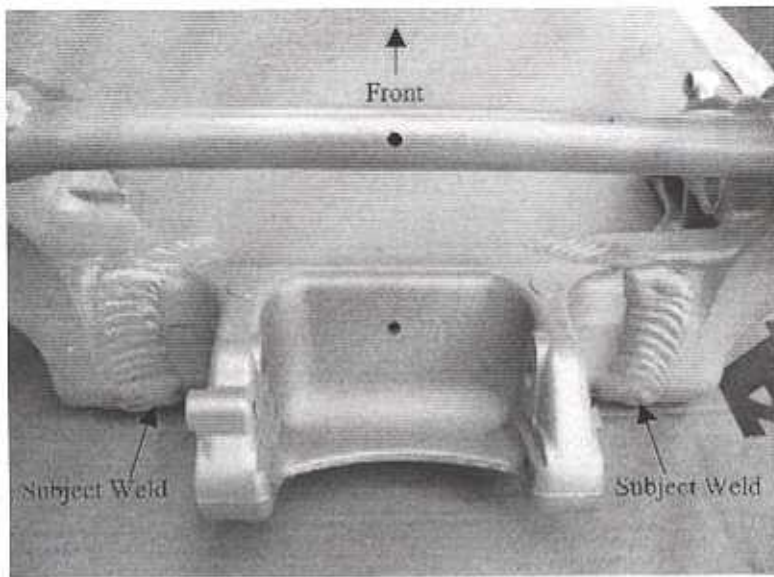
Photo 5 – Subject crossmember

ODI also inspected the replacement frame, built in May 2003, intended for the motorcycle described in Section 3.0. This afforded us the unique opportunity to fully view the subject crossmember and its welds. The frame shown was never installed as Honda elected to replace the damaged machine with a new 2003 model.

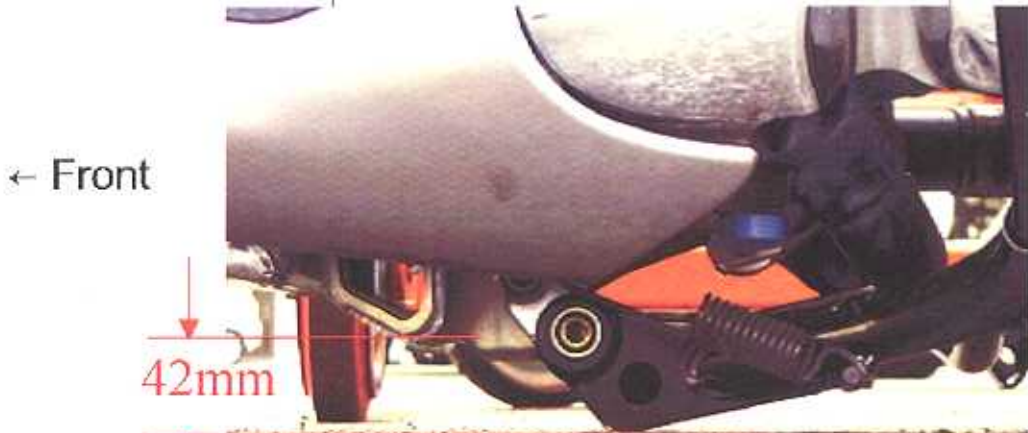
<p>The clearance between the pipe and the load surface is approximately 42mm; no contact. The bottom of the centerstand interferes with the road surface, but it does not impede running due to its curved shape.</p>	No abrupt movement

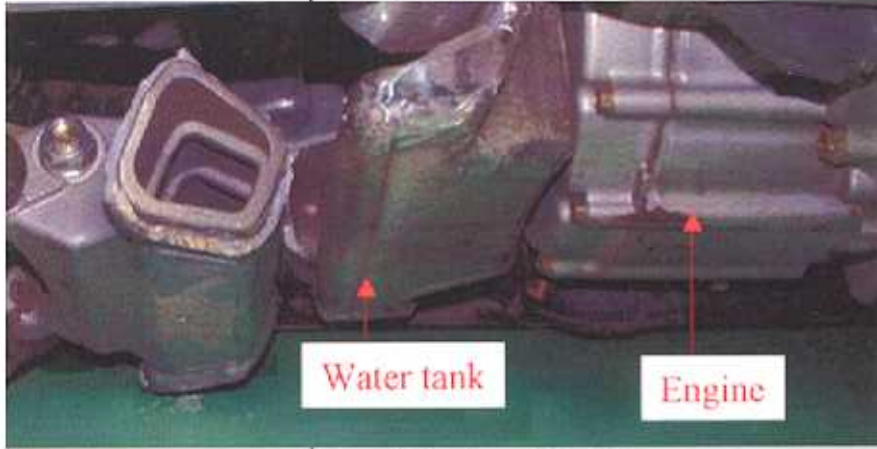
Potential problem	Phenomenon	Result
② fall	Slip by leakage of oil or coolant	The cross pipe hangs down out of place, but it does not come off nor cause any damage to the engine case and water tank.	No damage on the engine and cooling system.

Bank angle decrease	dynamic bank angle is 19° Normal running and turning are still possible.	Bank angle is slightly reduced.
	From the video of breakage test

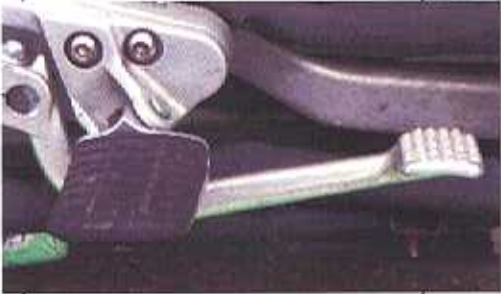
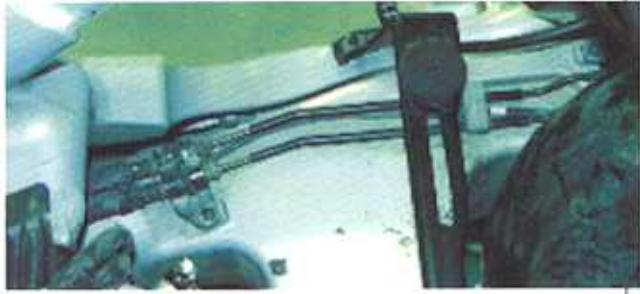
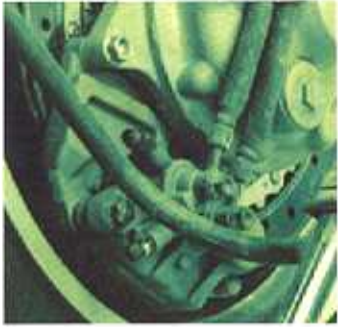
5. Safety Analysis—⑥

Potential problem	Phenomenon	Result
② Loss of control	Failure of drive train, transmission or braking system. <div style="text-align: center;">Pedal area</div>

No interference to related components <div style="text-align: center;">Brake pipe</div>

No damage to any related components <div style="text-align: center;">Caliper area</div>

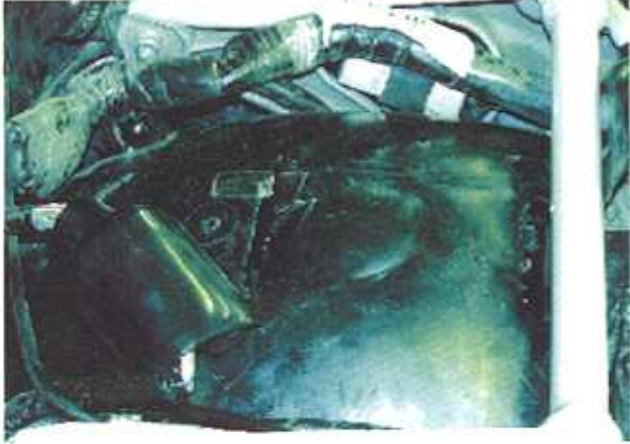
③ Fire	Electrical harness, open circuit and short circuit	No harness open circuit or short circuit after separation and prior to stopping

Electrical system is normal
④ lights inoperative	Lights become inoperative before stopping.

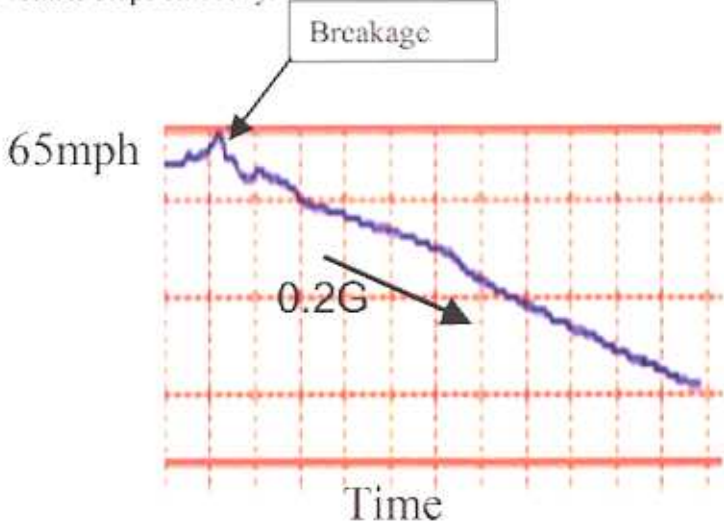
<p>No rear wheel lock occurs.</p>
	<p>Rear tire lock caused by interference from contact with fender.</p>	<p>During interference, the tire is not locked. The speed reduction is smooth, and the vehicle stops smoothly.</p>

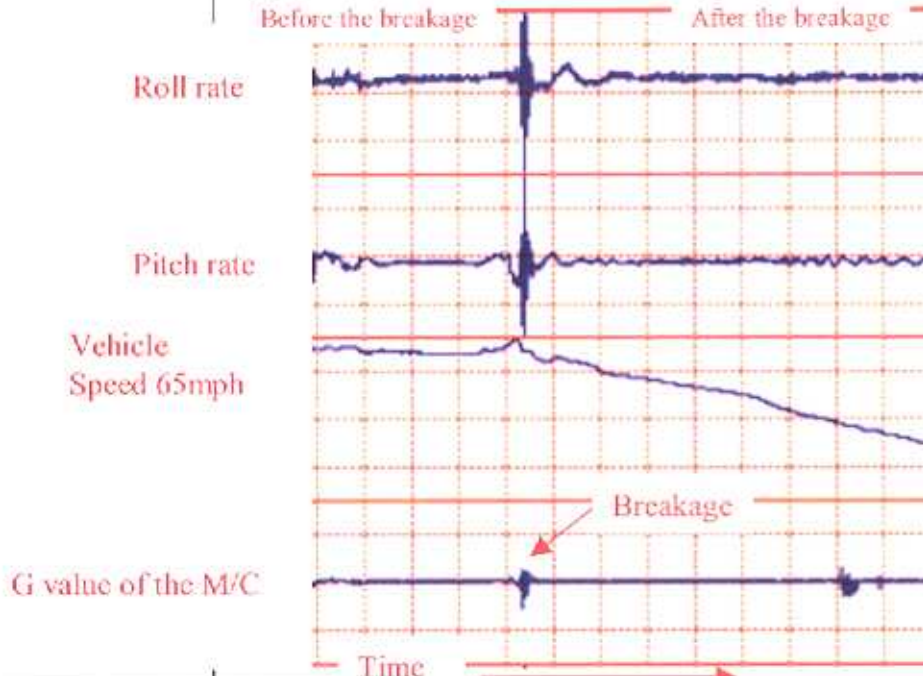
5. Safety Analysis — ⑧

Potential problem	Phenomenon	Result
⑥ Injury of the rider	Possibility of the rider being thrown from the bike by the shock of the cross pipe failure.	<p>Very slight shock at the moment of failure. No significant difference in pitch rate and roll rate of body before and after the failure.</p>

Rider remains on motorcycle.
	Parts dislodged from motorcycle can cause injury to the rider.	No parts are dislodged	No injury to rider.

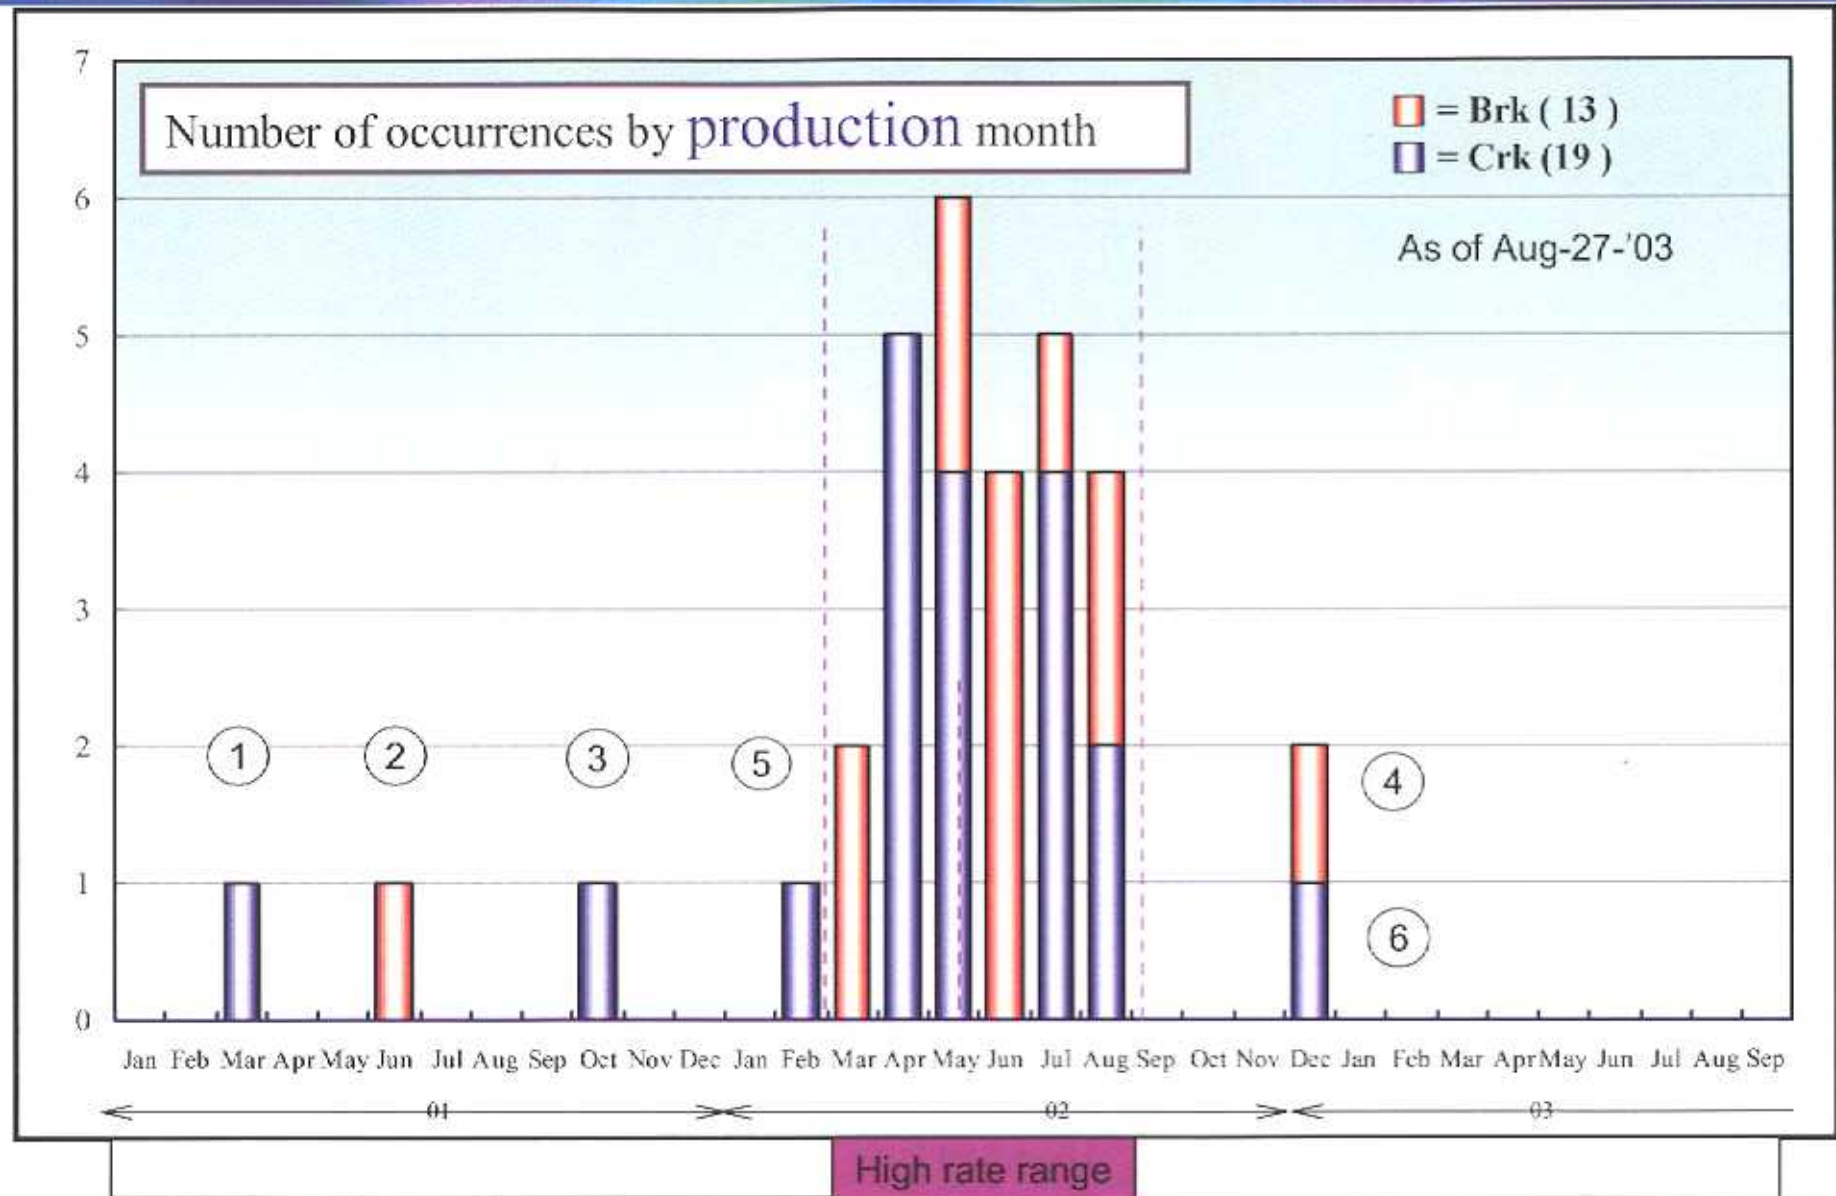
8 . Investigation of units outside of the range — ①

1	2	3	4	5	6
Mfg	Mar/'01	Jun/'01	Oct/'0 1	Dec/'02	Feb/'02	Dec/'02
State	LA	FL	NE	MI	PA	NY
Mile	50,067	1,416	27,634	3,445	17900	9387
Crk/Brk	Crk	Brk	Crk	Brk	Crk	Crk
Object	Unk	Pothole	Unk	Pothole		
Size	Unk	8"(depth)	Unk	(It felt big)		
MPH	Unk	35	Unk	20-25		
Riding		Single	Single	Single		
Weight of Rider						
Check result	Crack found at the seat rail.		Crack found at the seat rail.		Under investigation

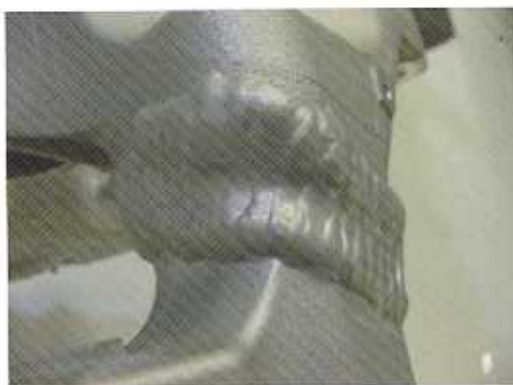
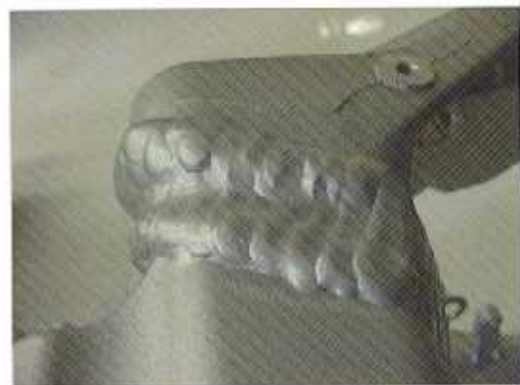
1 Concave Weld

No Good Welds

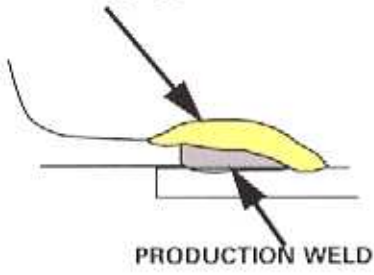
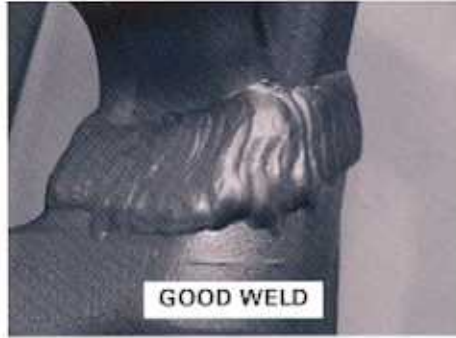
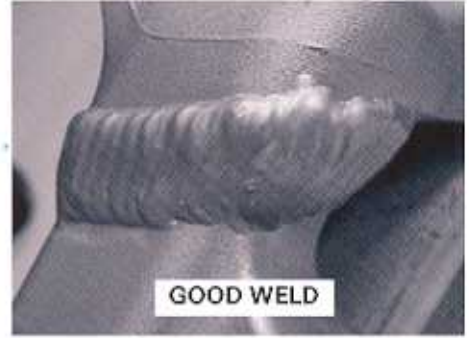
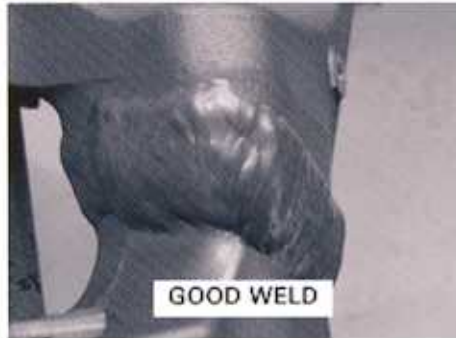
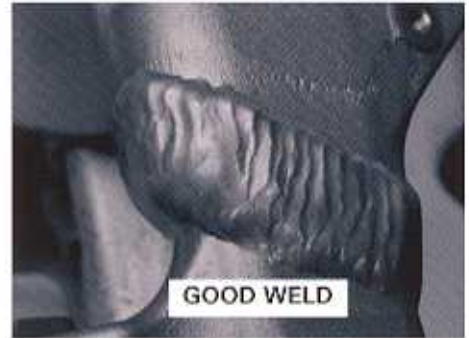
This section shows you how to accurately identify **GOOD** TIG welds.

New weld shape is convex,
overlapping production weld.

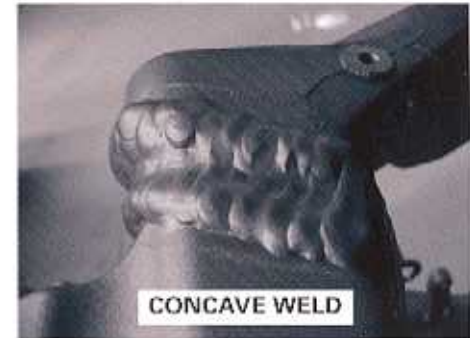
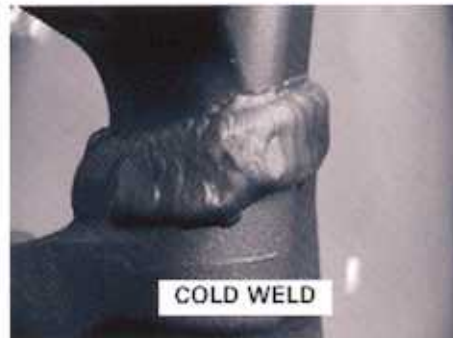
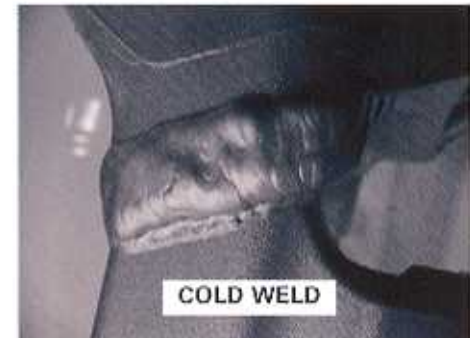
This section shows you how to accurately identify the following types of **NO GOOD TIG** welds: **Concave Weld**, **Cold Weld**.

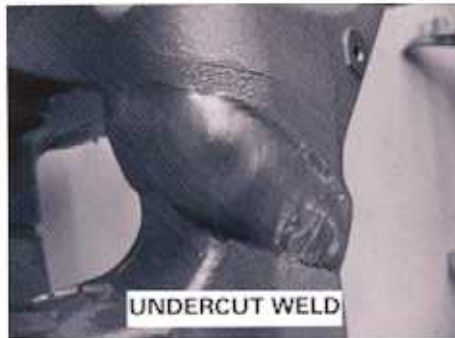
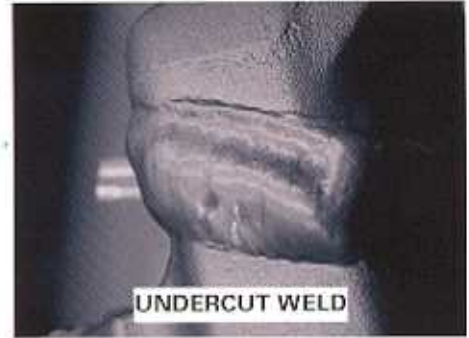
UNDERCUT WELD

This section shows you how to accurately identify the following types of **NO GOOD TIG** welds: **Undercut Weld**, **Dirty Weld**.

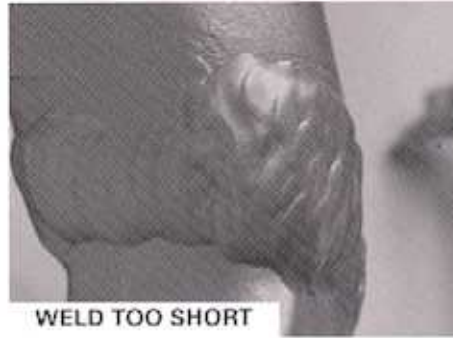
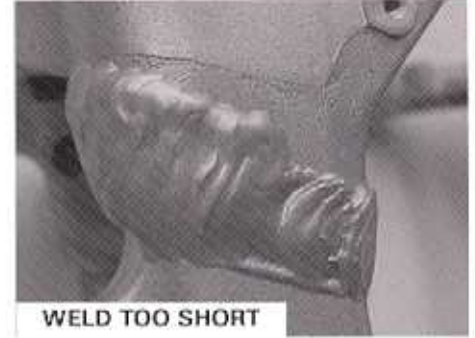
WELD TOO SHORT

This section shows you how to accurately identify the following types of **NO GOOD TIG** welds: **Weld Too Short**, **Weld Too Long**.

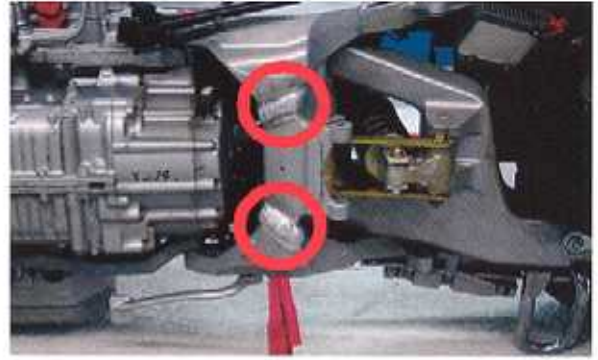
You will be welding at the locations shown above.

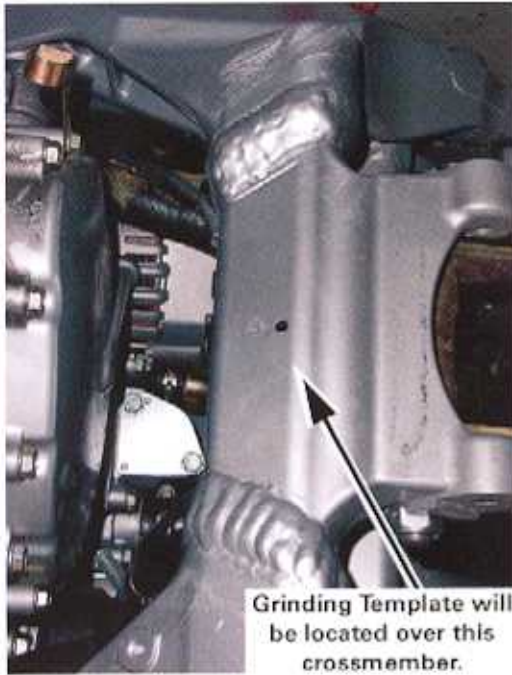
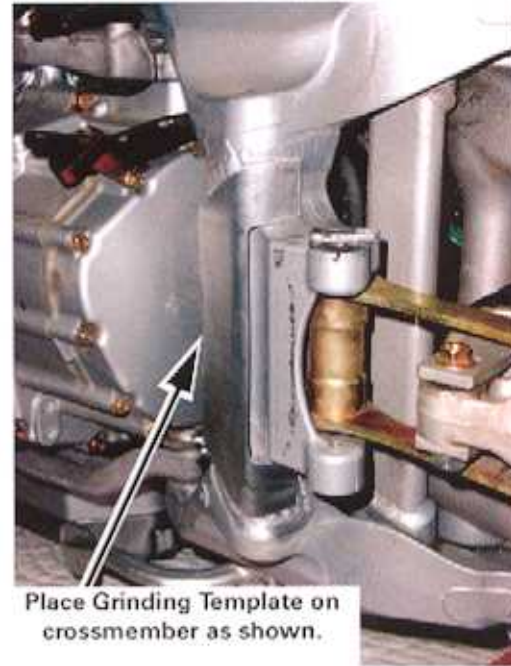
The illustrations below show the proper Grinding Template placement.

1. With the Grinding Template in the correct position, mark along the edges of the template as shown. Make sure you mark the entire length of the template. **DO NOT mark past the edges of the template.**

Length of grinding mark: 3.5" (Grind depth should be uniform.)

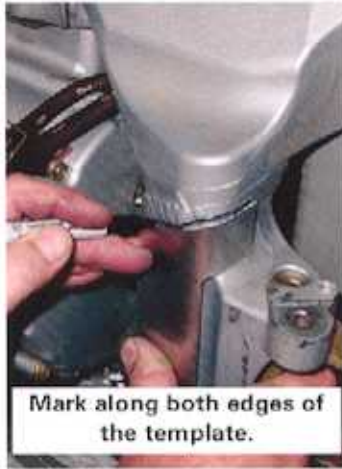
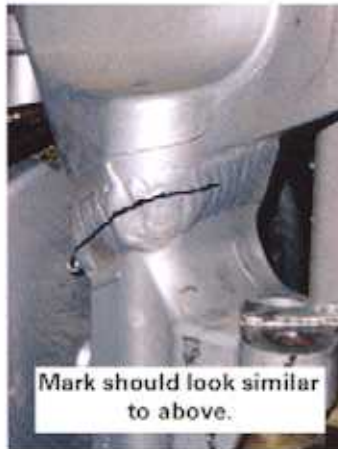
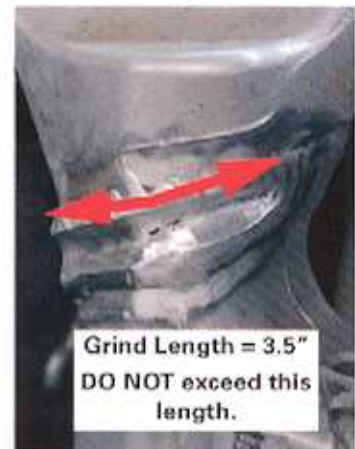
Mark around BOTH edges.

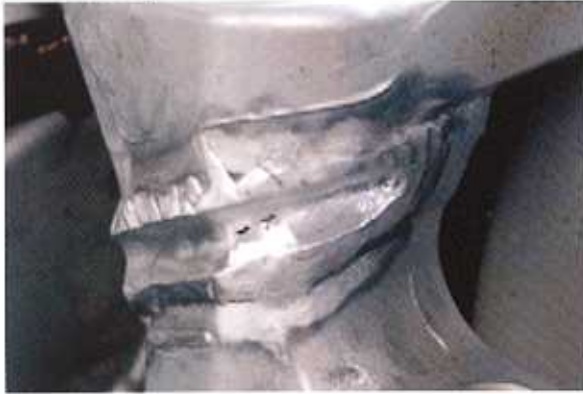
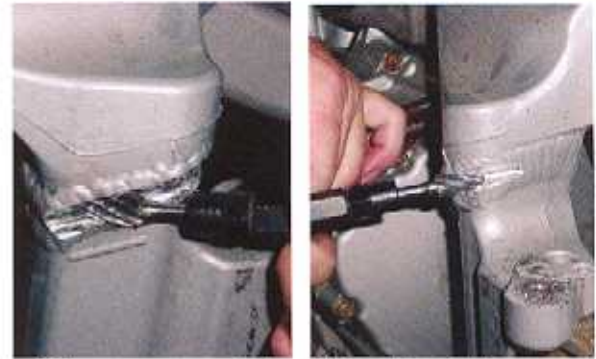
Finished grind should look similar to below.

Make sure you grind on both sides of the cross-member and to the full length of the grind mark.

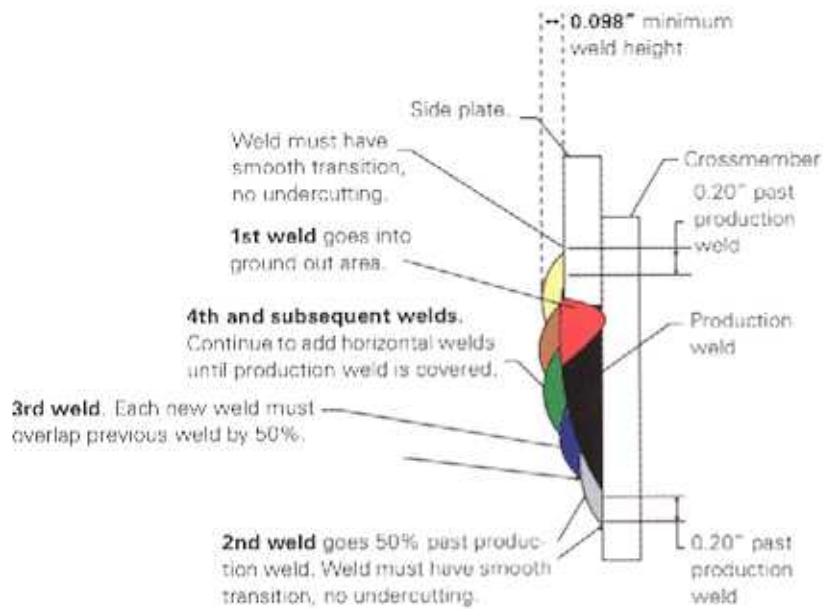
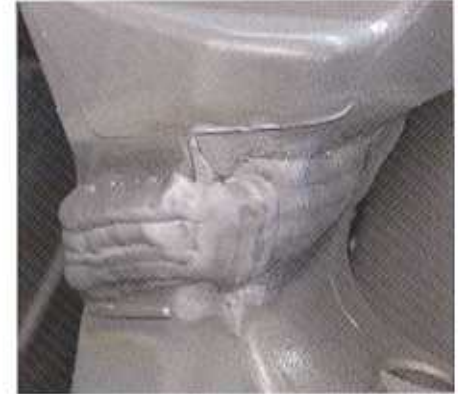
Welding beads with no wash applied.

The illustrations below show the correct weld techniques. Please follow these directions carefully.

NOTE: You will be **increasing** the size of the welds.
We estimate you will use 9 1/2' of 3/32" rod or 6' of 1/8" rod.
